Ringwood Mines/Landfill Site
Ringwood, New Jersey

The Path to a Final Remedy

Submitted to
National Remedy Review Board
U.S. Environmental Protection Agency

Submitted by
Ford Motor Company
May 28, 2013

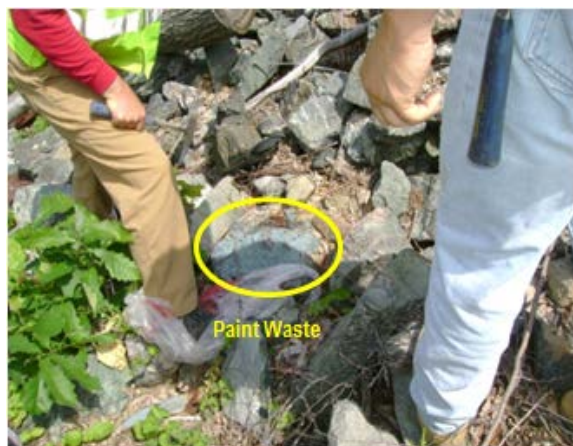
Paint waste was observed as a solid mass that resembles asphalt and often exhibits a weathered-gray color. Shown here (circled) among rocks and other debris is a small piece of paint waste that was removed and disposed of offsite during the removal actions.

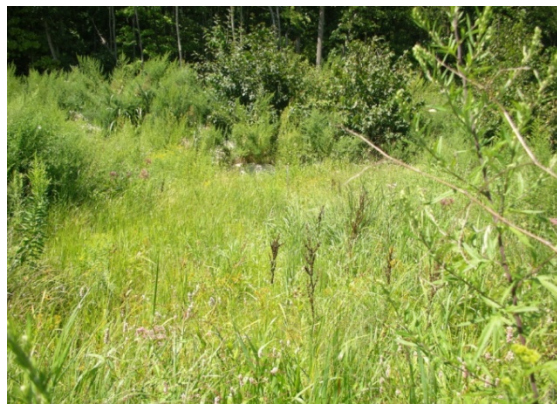
Portion of removal area SR-3 following excavation, backfilling with clean soil, and restoration with native plants

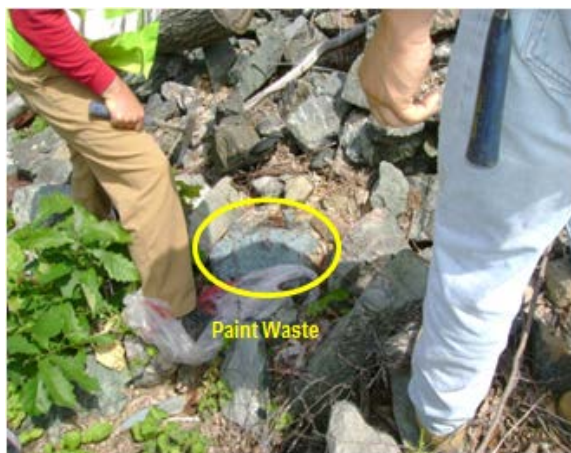
Historical surficial paint waste is typically observed as a solid mass that resembles asphalt and often exhibits a weathered-gray color. Shown here (circled) among rocks and other debris is a small piece of paint waste that was removed and disposed of during the removal actions.
